NISTUNE TECHNICAL BULLETIN #002

TITLE : Correction of ECU Air Flow Meter modifications

Models covered: HR31, RB20DET, CR31 RB30E, VLT RB30ET, Z31 VG30E/ET (1986-1987)

Date: 26 September 2009. Revised 26 March 2012

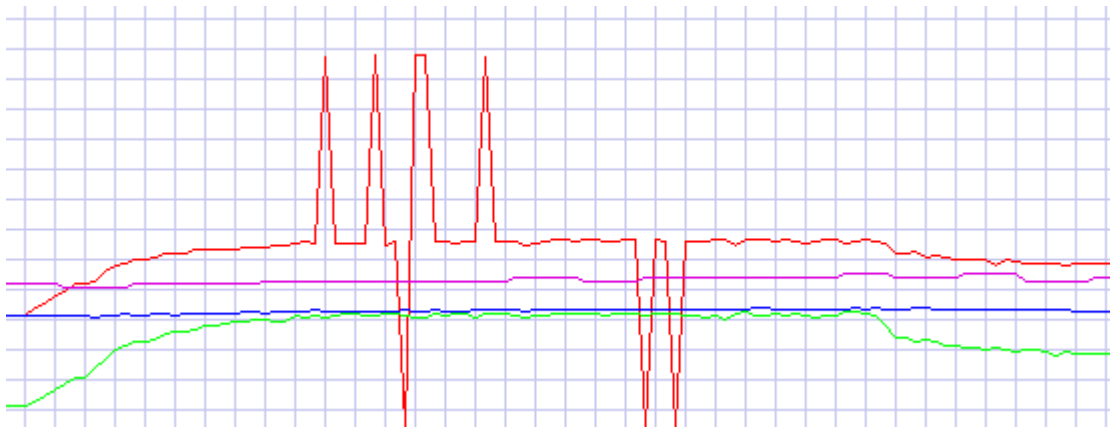
Following this modification it has been noticed during field testing that logs have indicated that 0 and 5 volt spikes in the AFM signal received by the HD46510 chip have been received and processed as can be seen below:

The removal of the opamp from the circuit has affected filtering of the ECU and occasional spikes in the fuel injection could be potentially noticed. In the log above TP was not affected, so the map points accessed were not changed.

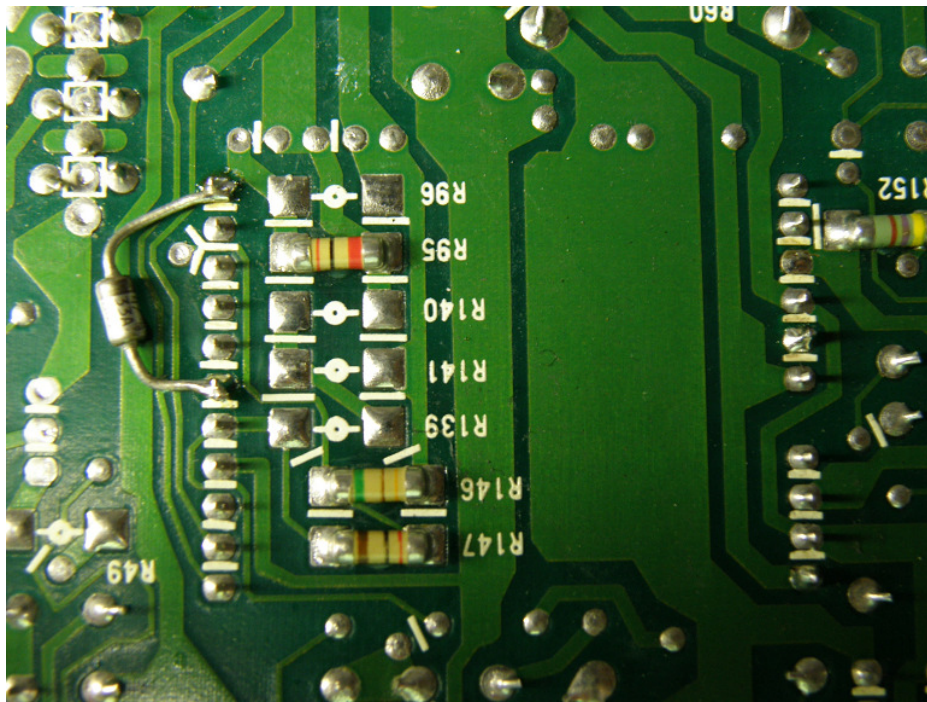
5. Retaining the zener diode is still recommended, as the opamp may not protect against over voltage from the AFM if it occurs. It will need to be moved to the input side of the ECU

Solder the banded end of the zener diode to pin 11, and the other end to pin 6 as pictured below.
