Nistune Type 1 Diagnostics Technical Notes V1.2

(JECS ECCS 1984-1989 Legacy Engine Control Units)

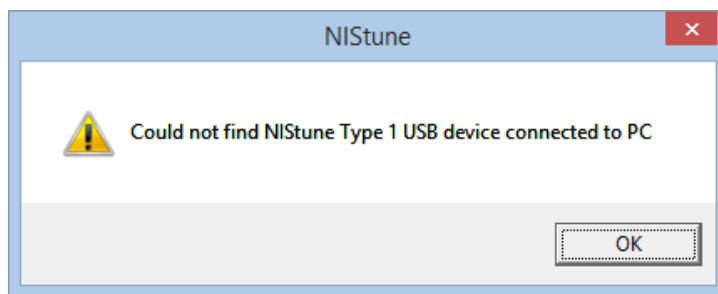
After this when you try and connect to the vehicle using the 'Consult' button Nistune should recognize the connection to the Type 1 board and attempt connection. If the drivers for the board are not installed, or if the board is not connected to the PC or there is a problem with the cable (or the FTDI USB chip on the Type 1 board was somehow damaged) then you will see the following error message:

Nistune cannot see the Type 1 board

Firstly check your Type 1 board can be 'seen' by Windows and that the drivers appear to be installed correctly. Inside Windows open up Control Panel > System > Device Manager > Universal Serial Bus Controllers

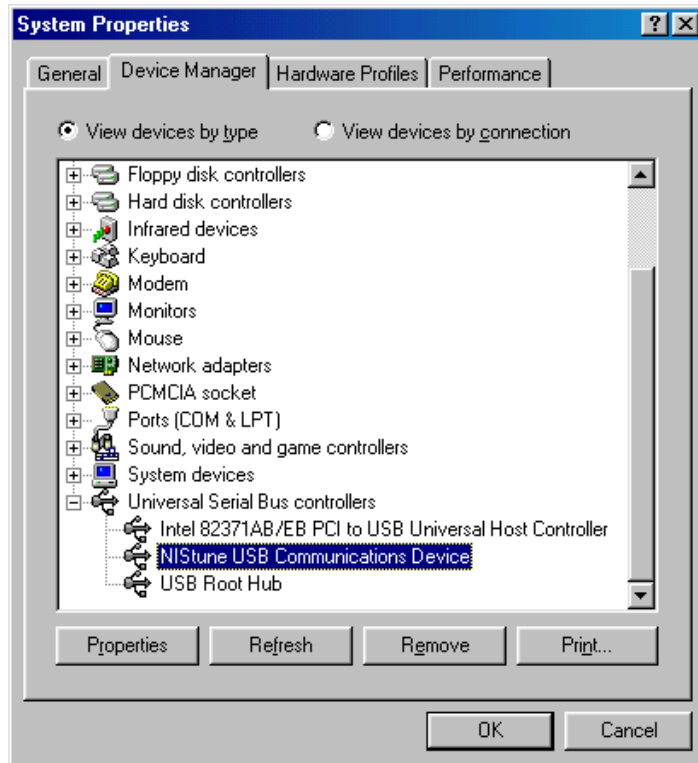
The 'Nistune USB Communications' or 'Nistune Type 1 board' device should show up here as working. If not then reinstall Nistune and ensure the drivers have been selected for installation.

If driver has previously been installed and doesn't work (it might have an exclamation mark against it) then reinstall the drivers. Do this by clicking on Properties and then Reinstall Drivers. Point to the driver location where you installed Nistune to (usually Program Files (x86)\Nistune)

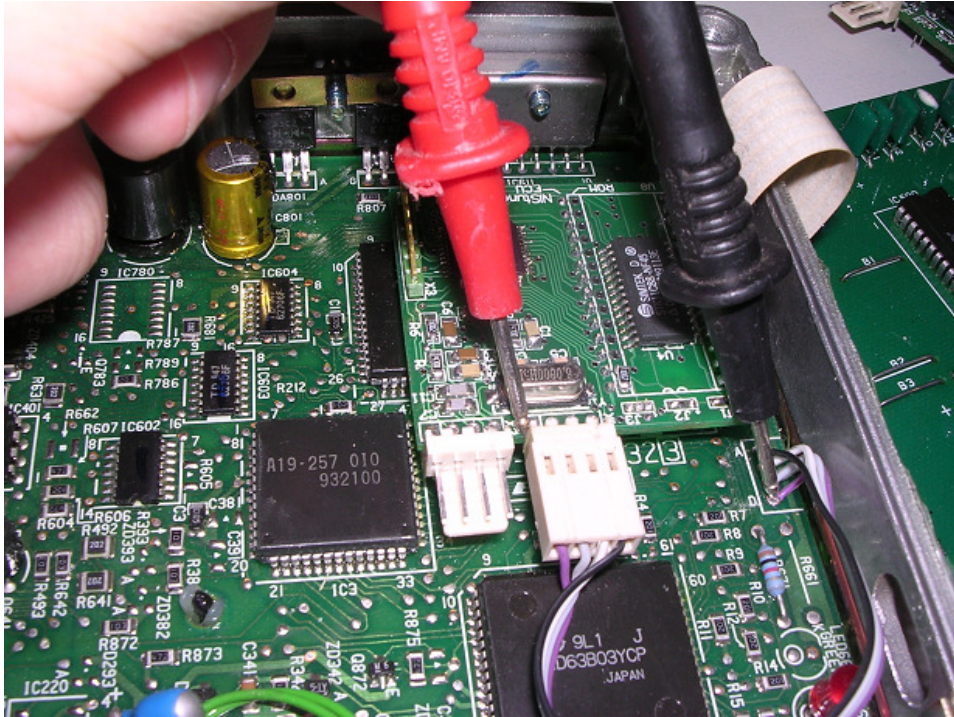
Later model NISTune Rev 3-4 boards checking from the header pin (D) to pin 1 on the Nistune board.

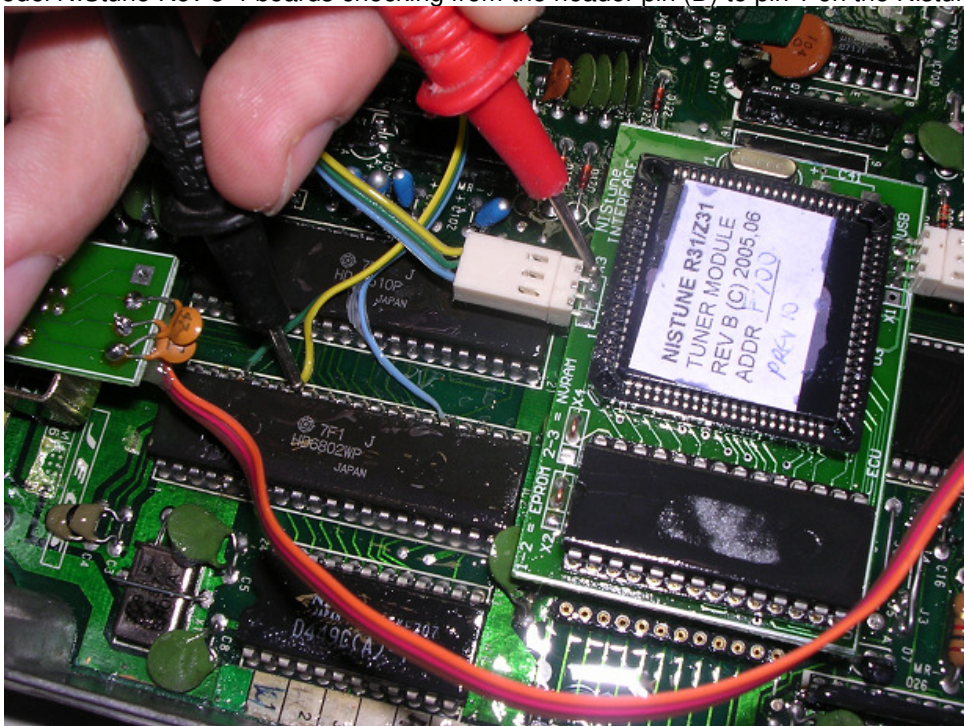
Earlier model Nistune Rev B board. Measuring CPU is connecting to the socket on the Nistune board

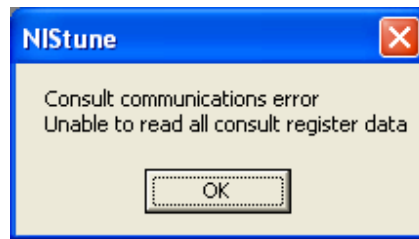
This error is due to an internal problem with the board firmware not matching what the Nistune software is trying to talk to.

Make sure correct vehicle is selected in Nistune. Otherwise contact Nistune for support with the particular error message you are getting
